FINAL DESIGN REPORT / ENVIRONMENTAL IMPACT STATEMENT

Appendix L – Bridge Information

Highway Project
P.I.N. 1721.51
BINs: 1033141 / 1033142
Interstate 87 (I-87) Exit 4 Access
Improvements
Albany County

BIN 1033141

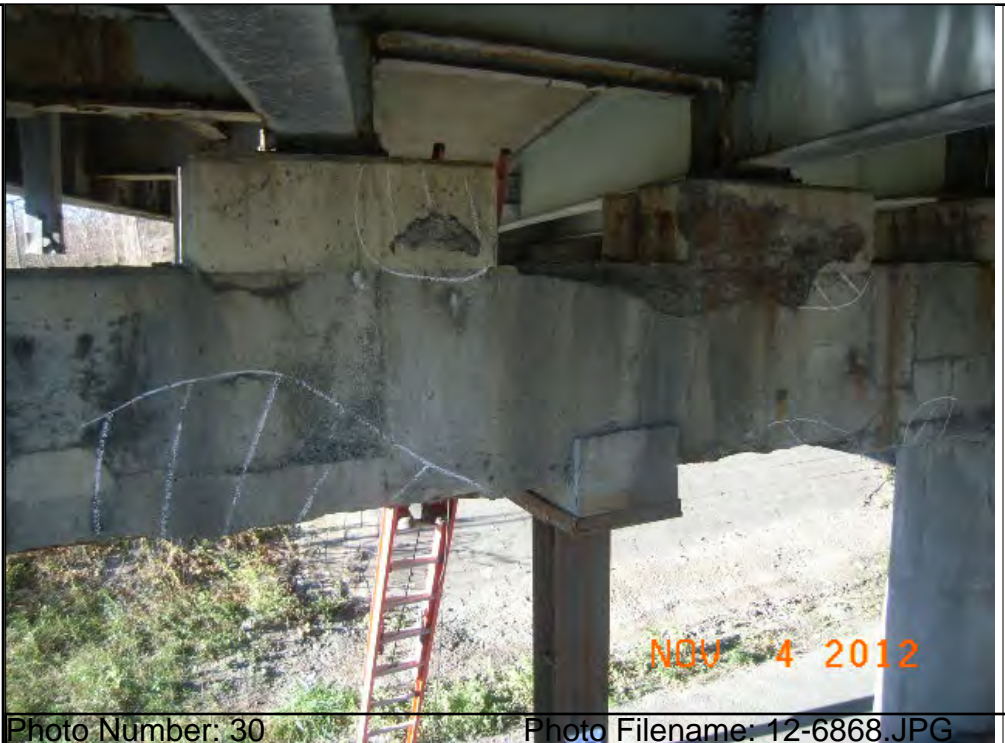
Photo Number: 30

Pier - Pedestals - Pier 1
- Peds 5 and 6 from end side
Pier - Top of Cap Beam -
Pier 1 - Bay 5 from end side
Pier - Cap Beam - Pier 1
- Right half from end side

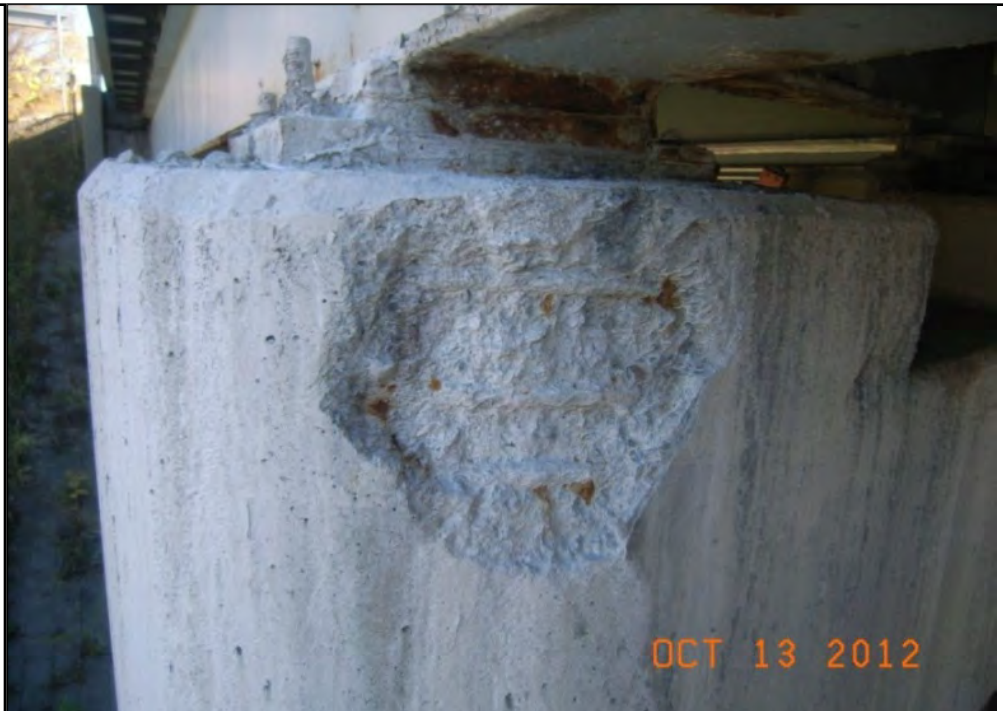
Photo Number: 31

Pier - Pedestals - Pier 2
- Ped 1 Begin face

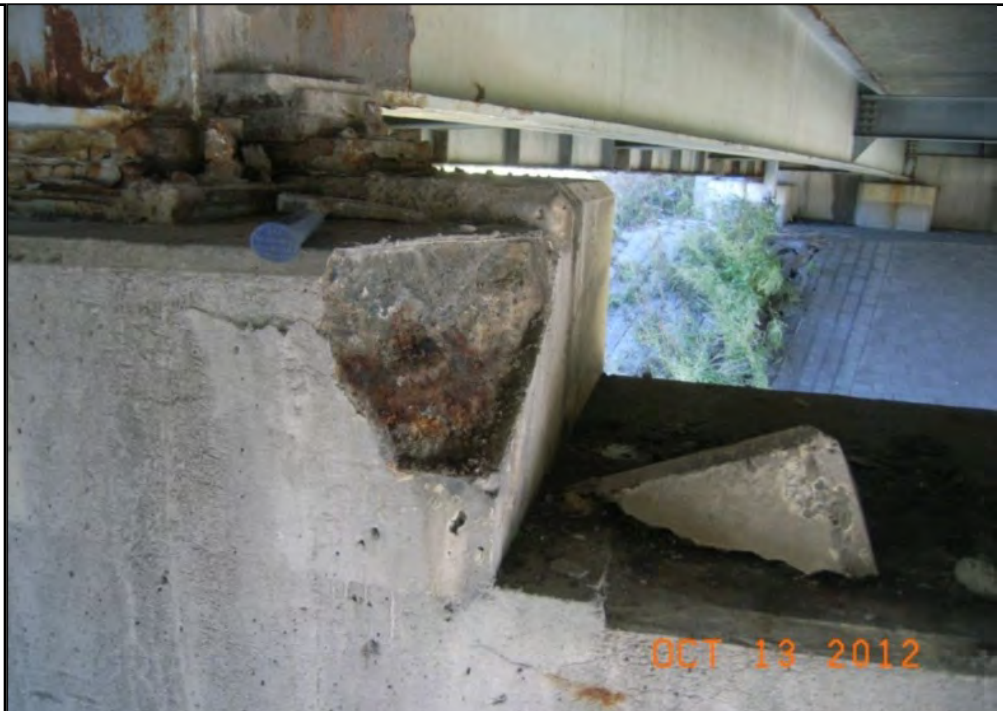
Photo Number: 32

Pier - Pedestals - Pier 2
- Ped 2 - Begin Right

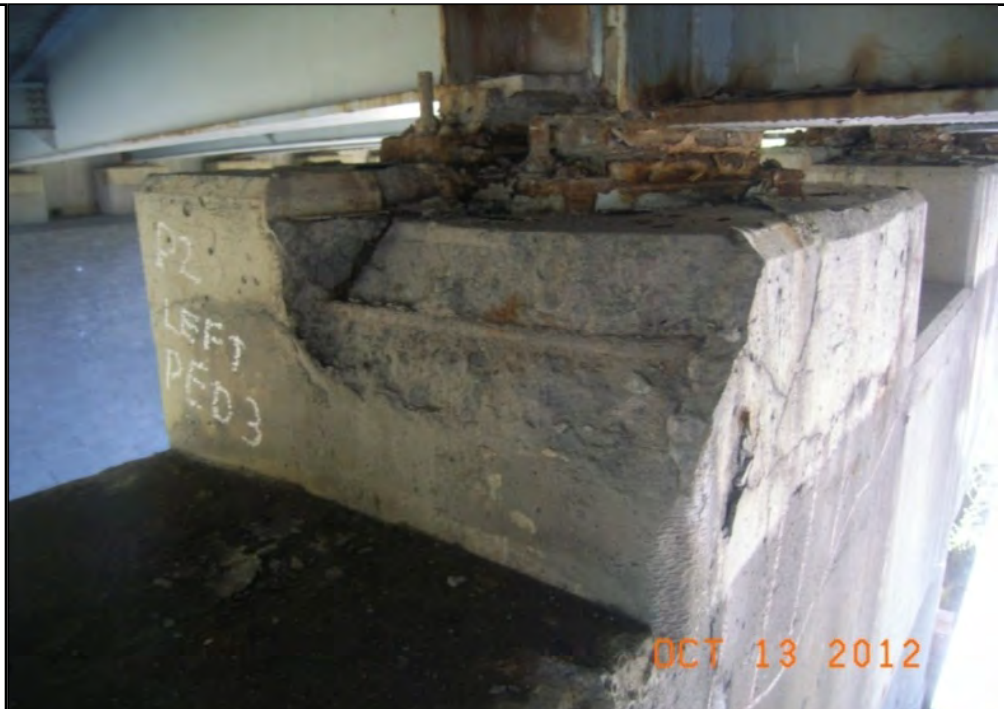
Photo Number: 33

Pier - Pedestals - Pier 2
- Ped 3 - Left Begin

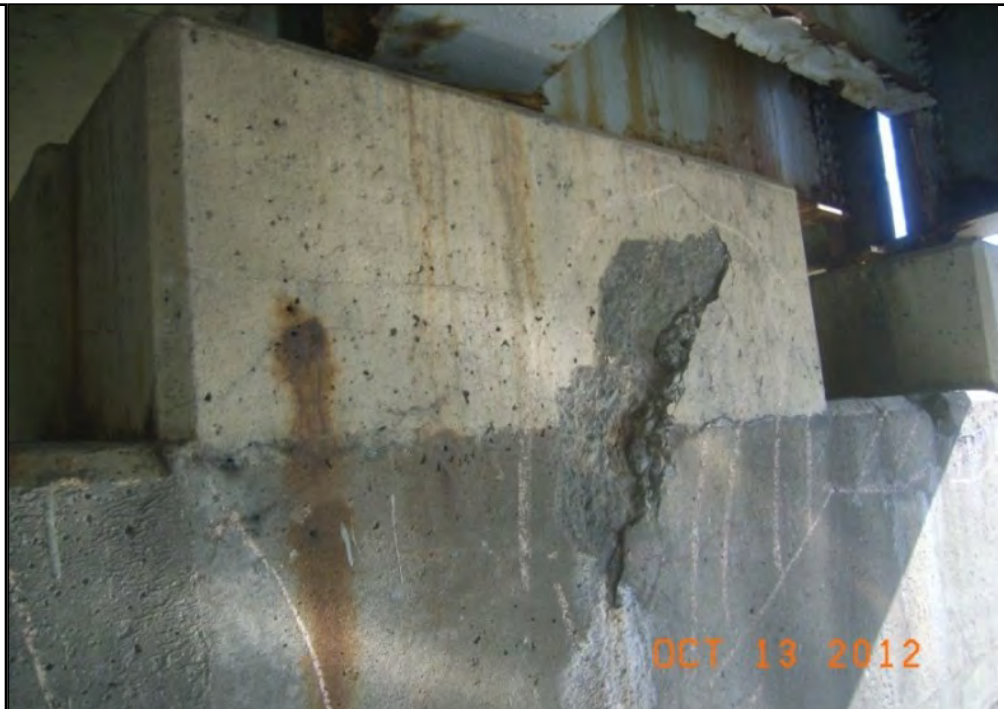
Photo Number: 34

Pier - Pedestals - Pier 2
- Ped 6 Begin face

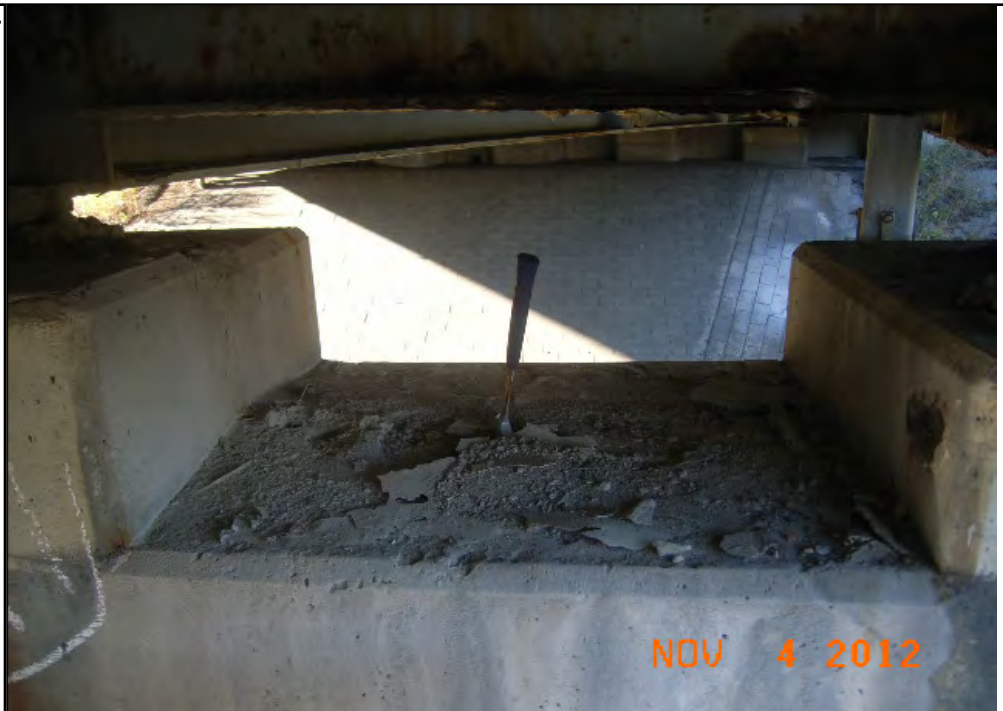
Photo Number: 35

Pier - Top of Cap Beam -
Pier 1 - Bay 1

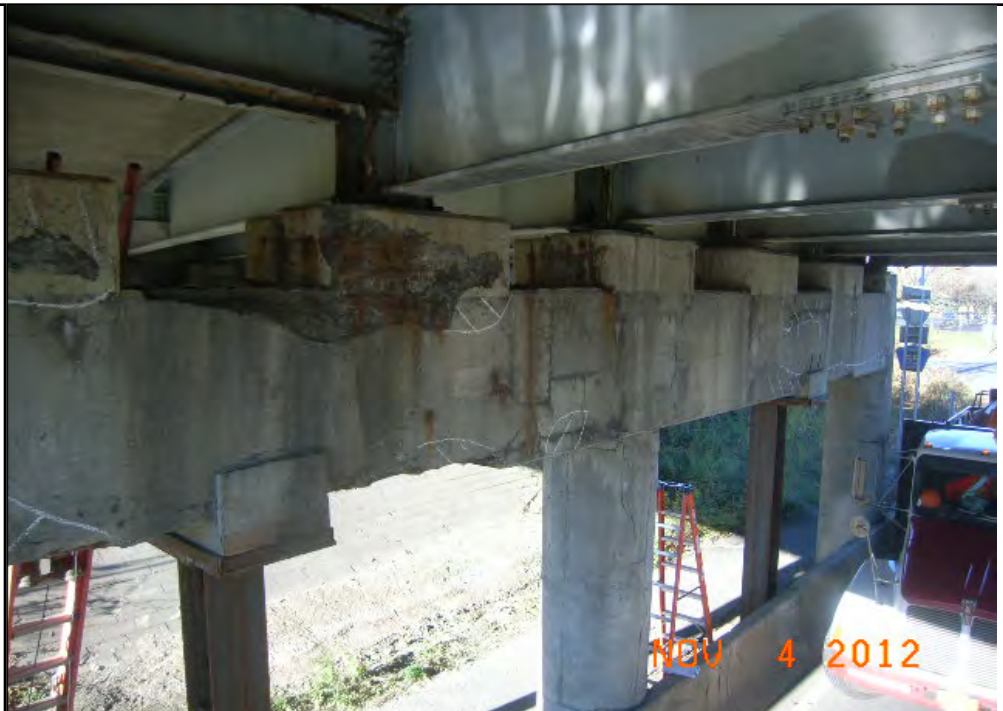
Photo Number: 36

Pier - Cap Beam - Pier 1
- End Face from Right

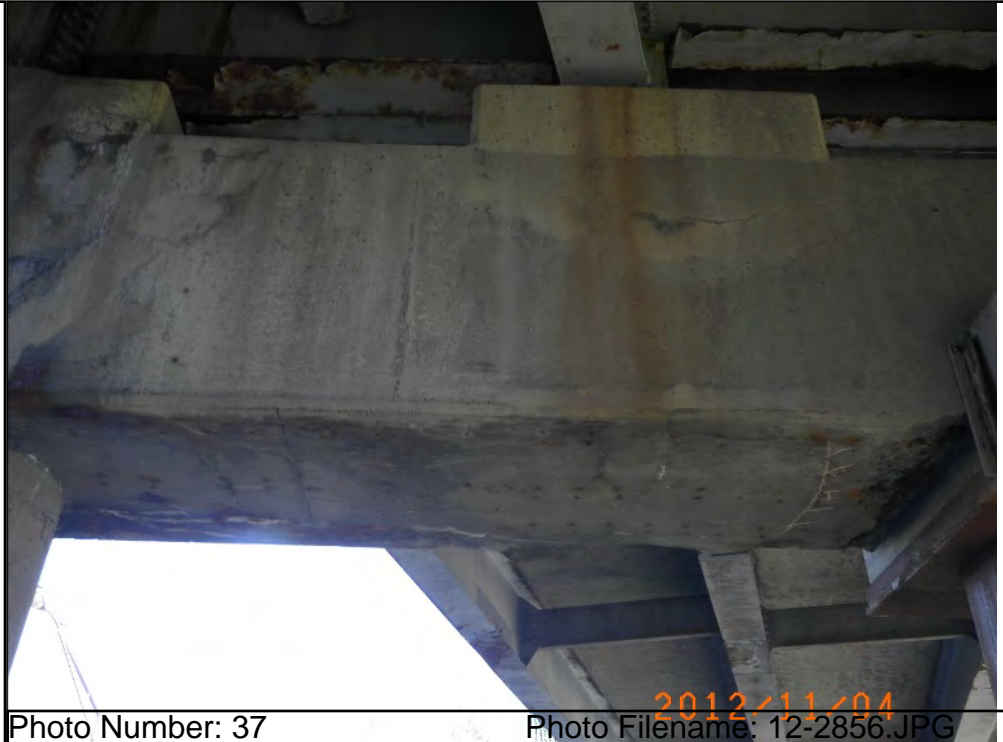
Pier - Cap Beam - Pier 1
- Begin face between Col
1 and Bay 1 Temp Steel
Column

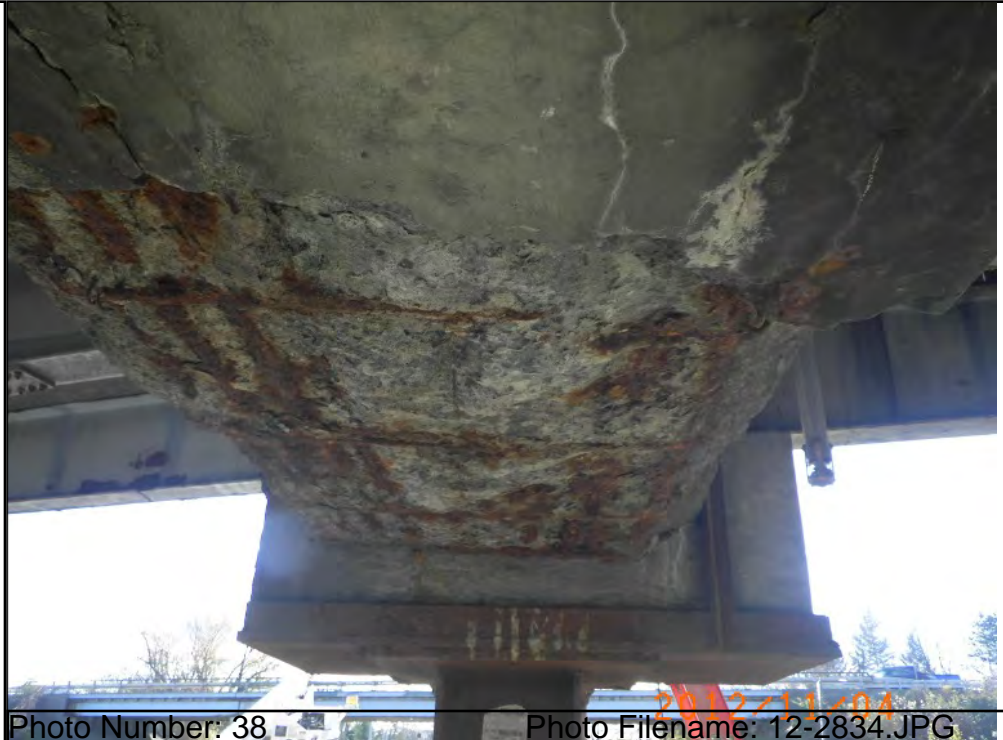
Pier - Cap Beam - Pier 1
- underside between Bay
1 Temp Steel Column and
Column 2

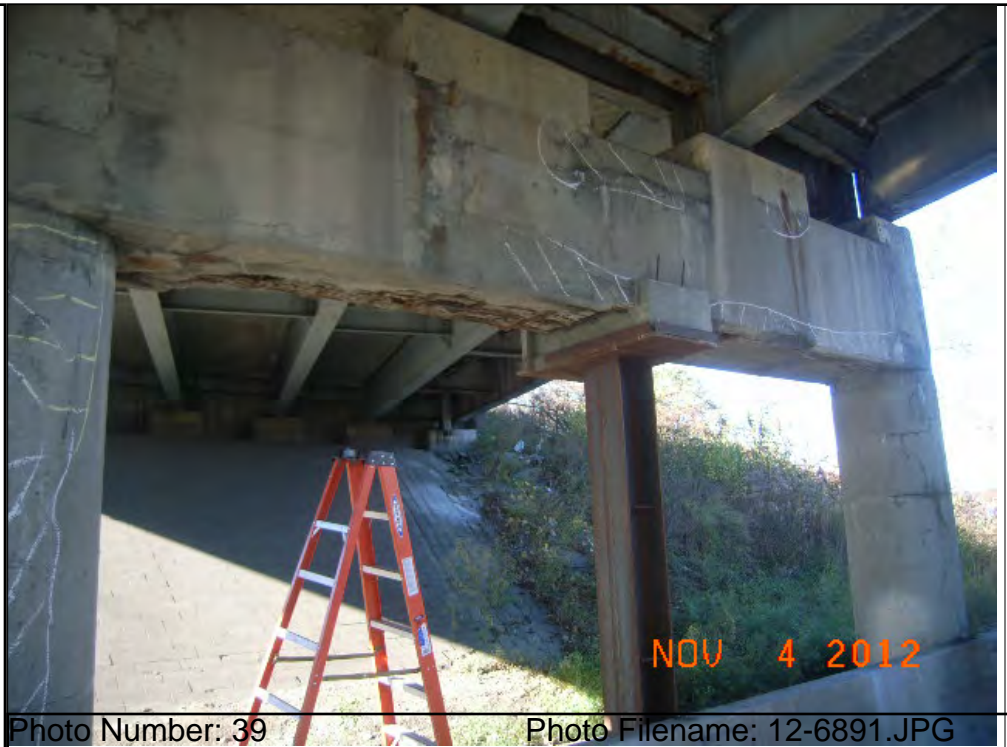
Pier - Cap Beam - Pier 1
- End Face - Left half

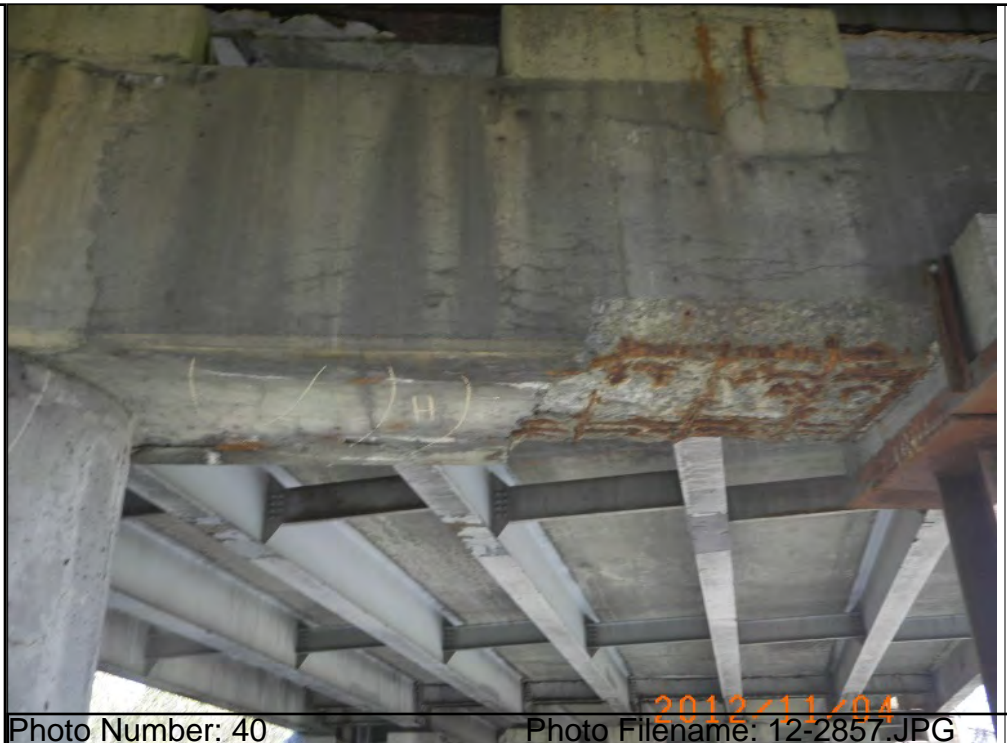
Pier - Cap Beam - Pier 1
- End face between Bay 2
Temp Steel Column and
Column 3

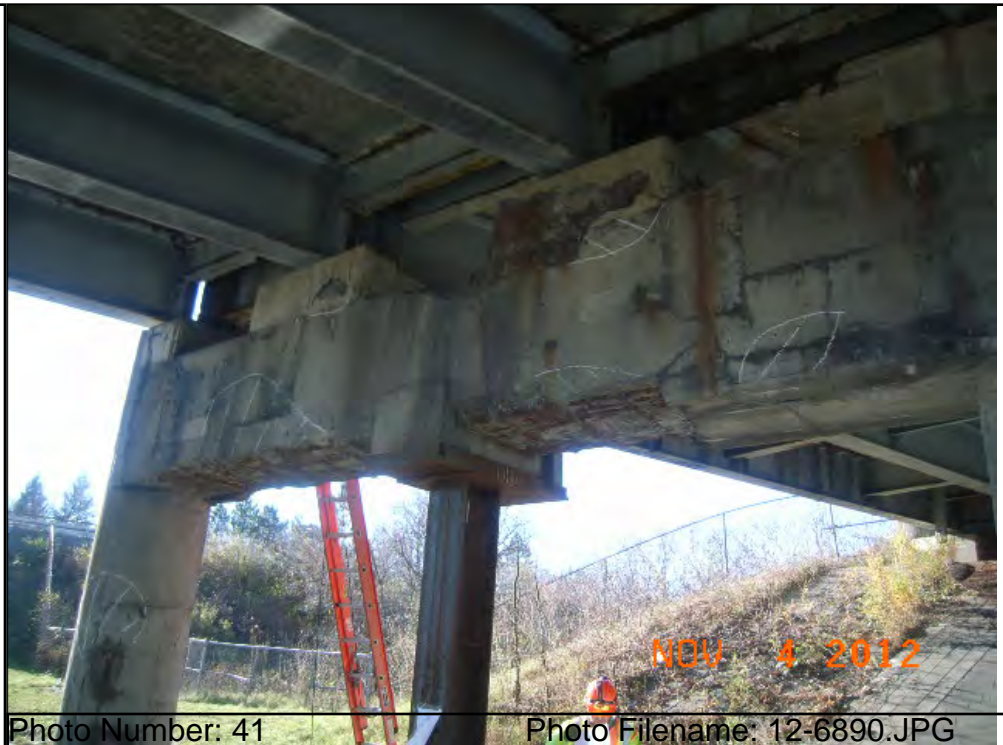
Pier - Cap Beam - Pier 1
- End Face - Right half

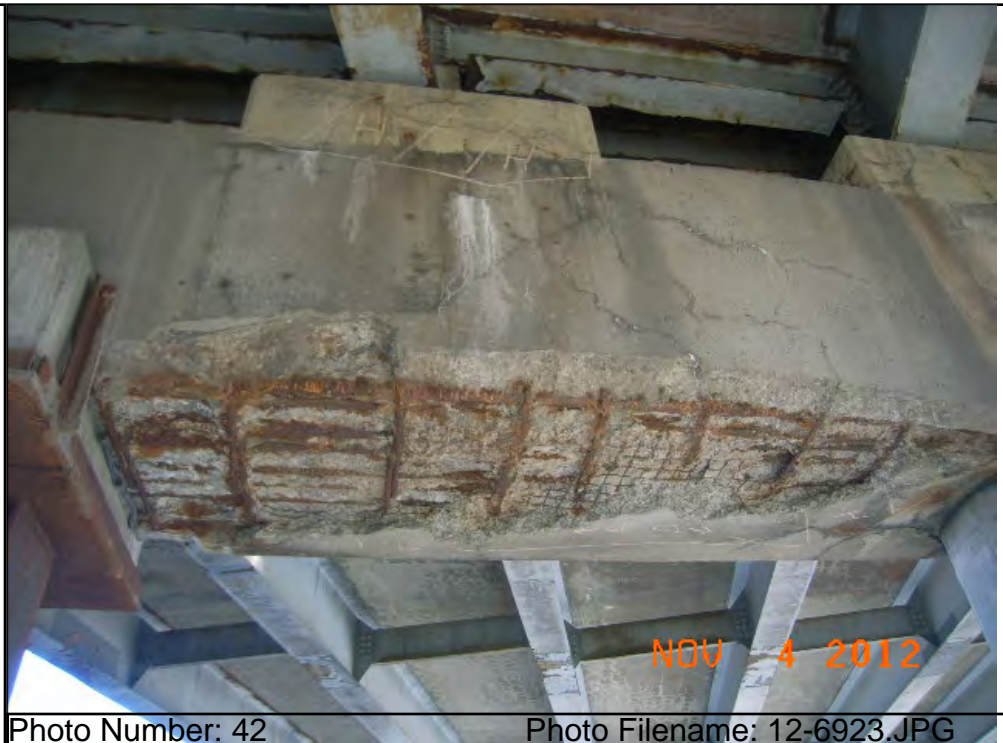
Pier - Cap Beam - Pier 1
- Begin face between Bay
2 Temp Steel Column and
Column 3

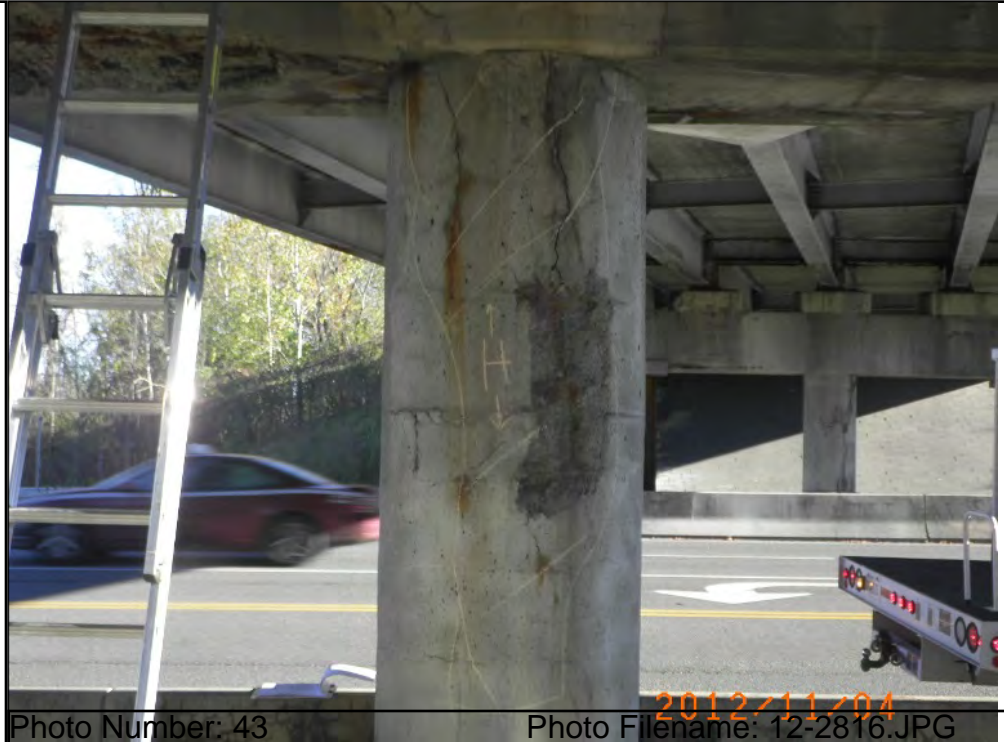
Pier 1 - Column 2 -
Begin Face

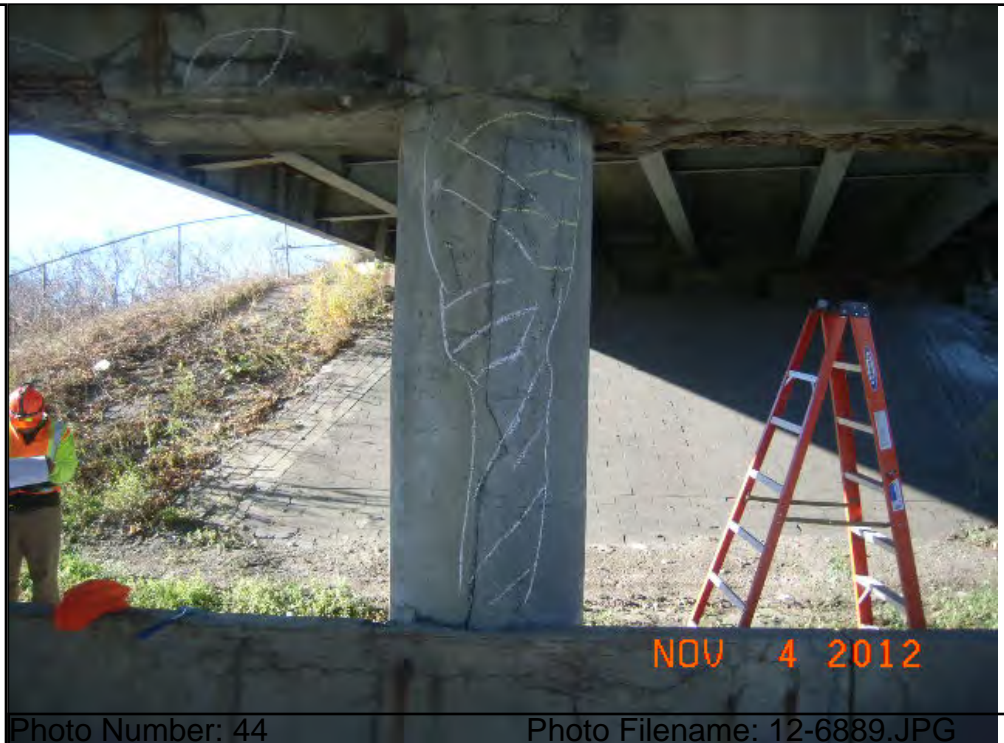
Pier 1 - Column 2 - End
Face

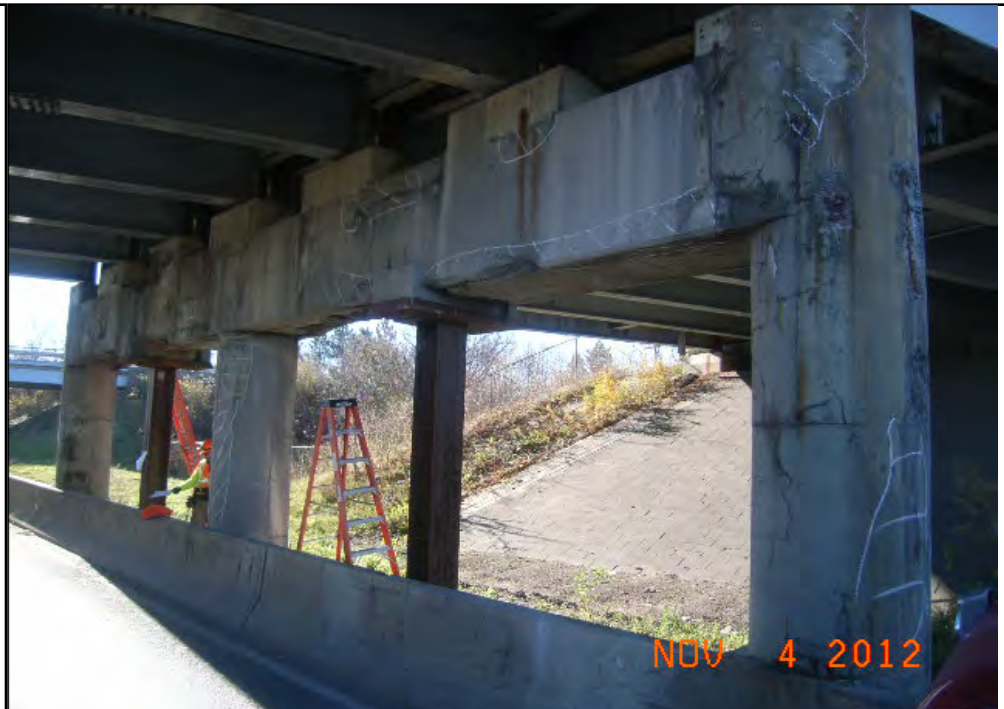
Photo Number: 45

Pier 1 - Pier Columns -
overview from End Left

- The End faces of all three columns and the outside faces of Columns 1 & 3 contain significant areas of hollow sounding concrete and extensive map cracking for the full height of the columns (photos 12-2816, 6889 & 6892). It is estimated that these conditions affect 15-25% of the face of all three columns.
- There were a few spalls:
 - o Left face of Column 1 - near the top - up to 9 inches wide, 2 ft high, with one exposed rebar - photo 6823
 - o End face of Column 1 - near the top - less than 1 square foot with a stirrup and main bar slightly exposed - photo 12-6823
 - o End face of Column 2 - near its center vertically - up to 9 inches wide and 3 ft high - photo 12-2816.
 - o End face of Column 3 - near the top of the barrier - two areas of up to 1 square foot each with one exposed rebar - photo 12-6888.

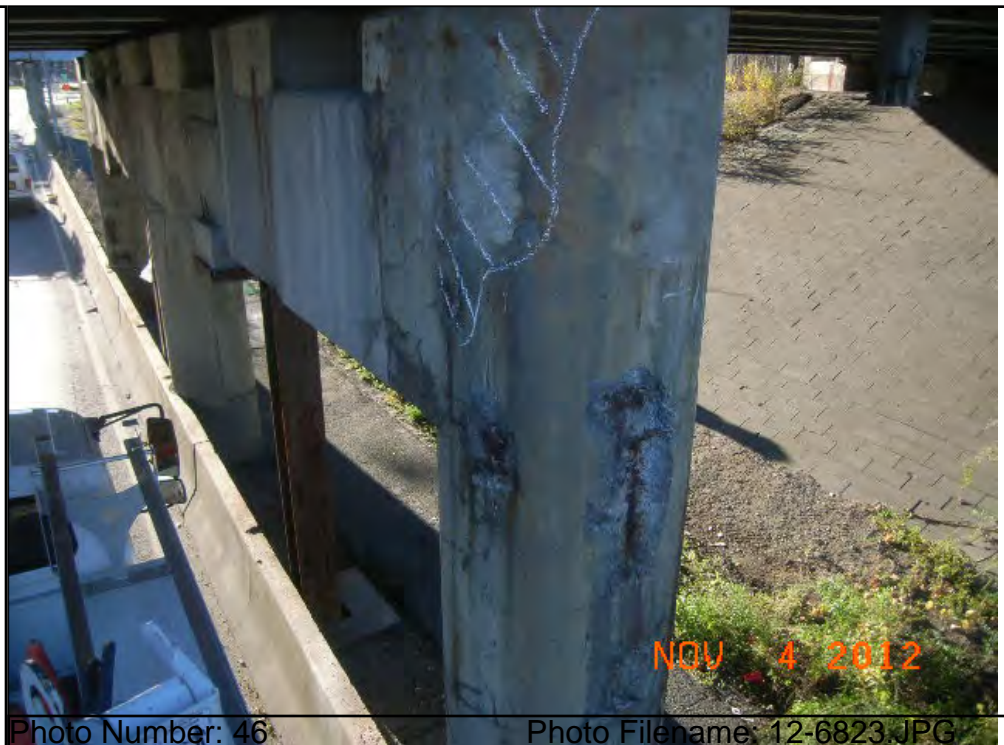
Photo Number: 46

Pier 1 - Column 1 - End
Left Face

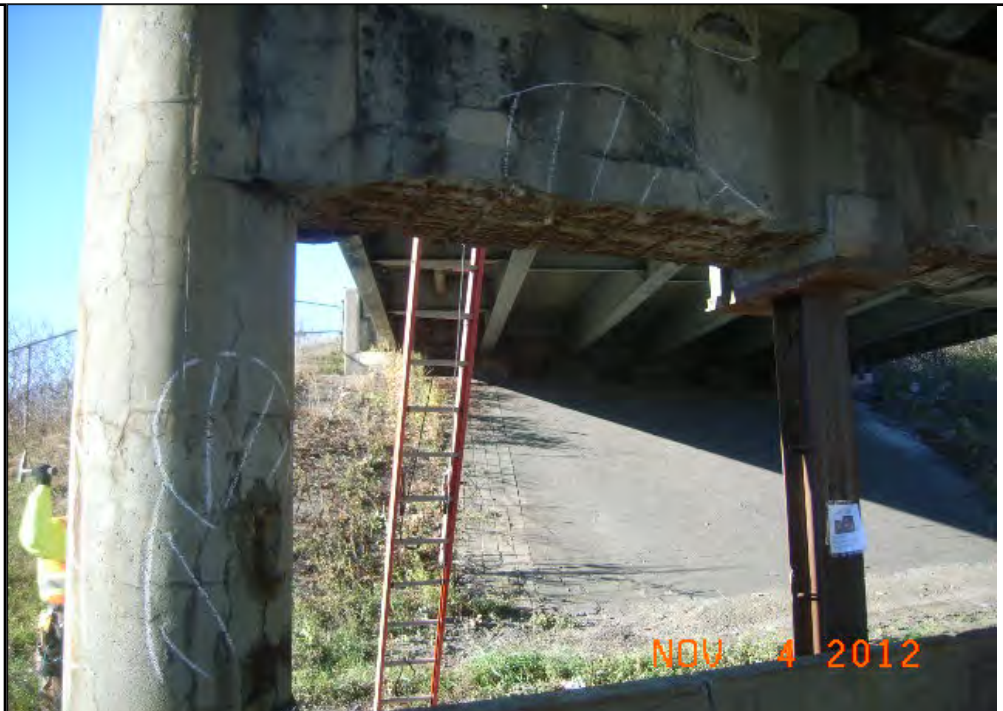
Photo Number: 47

Pier 1 - Column 3 - End
Face

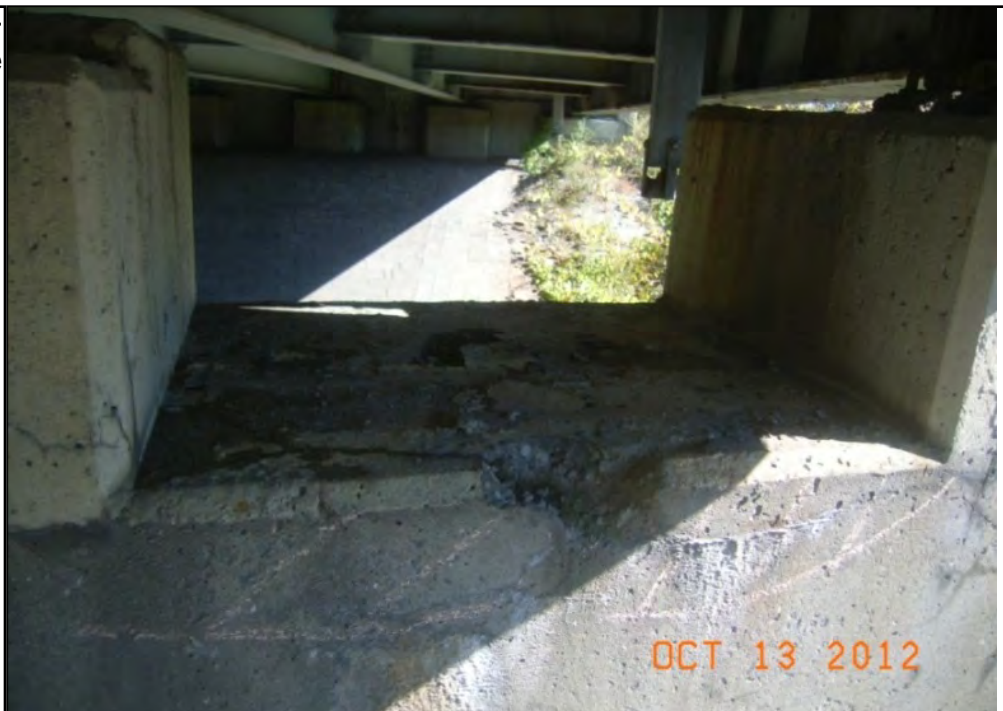
Photo Number: 48

Pier - Top of Cap Beam -
Pier 2 - Bay 6, Begin edge

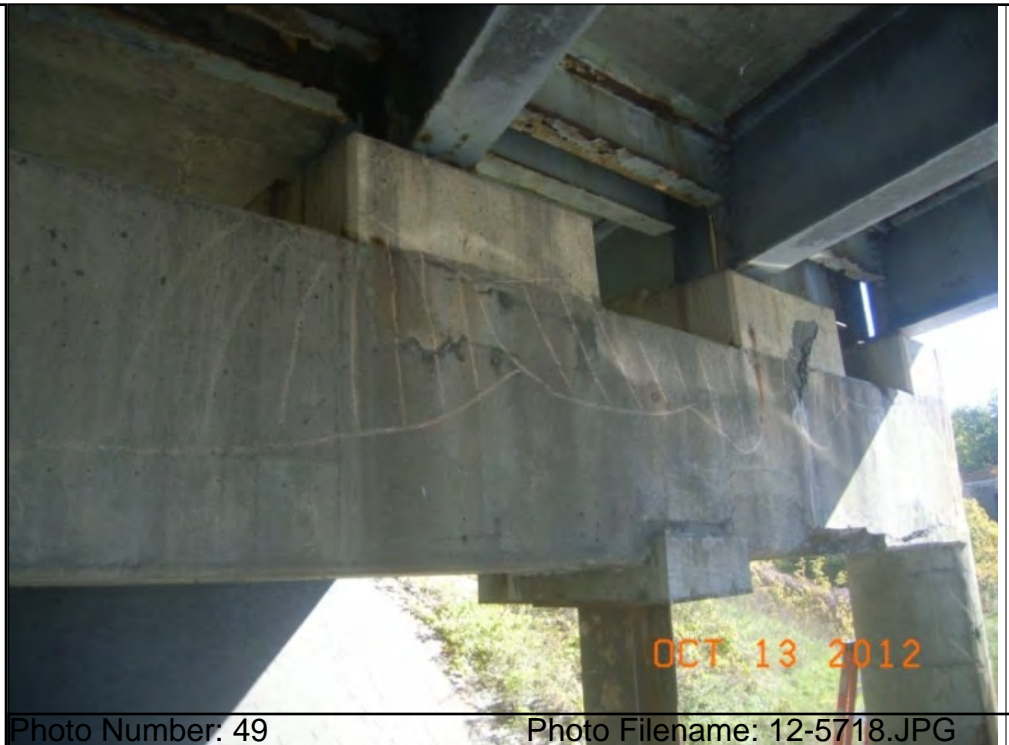
Photo Number: 49

Pier 2 - Cap Beam -
Begin face - Right half

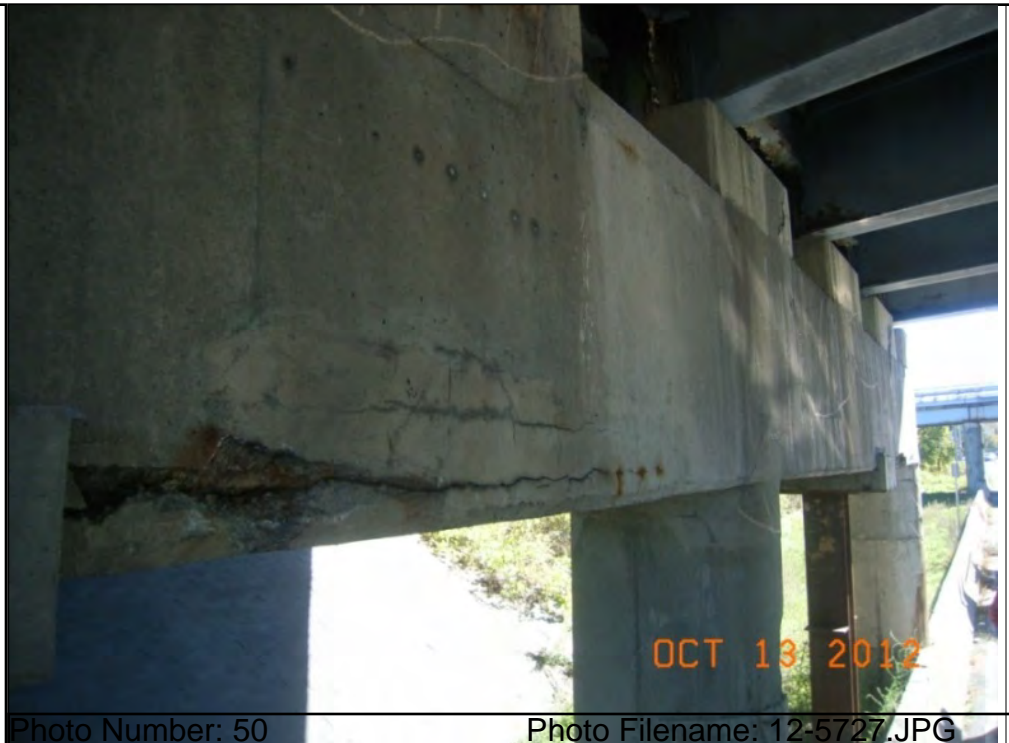
Photo Number: 50

Pier 2 - Cap Beam - Bay
1 - Begin face - right of
Left Temp Steel Column

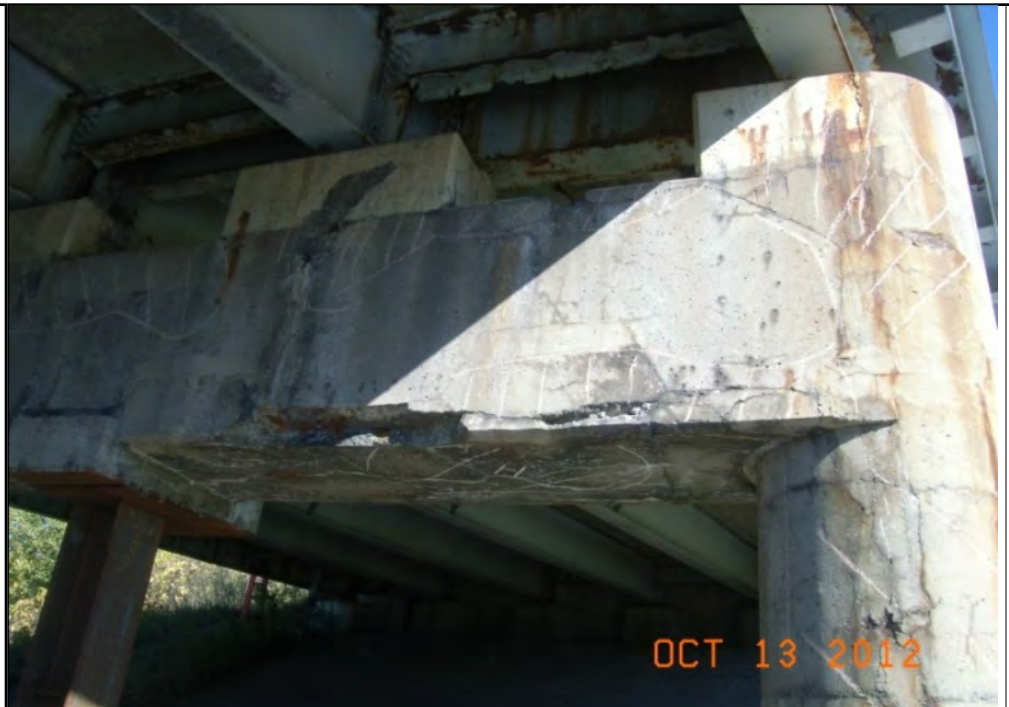
Photo Number: 51

Pier 2 - Cap Beam - Bay
2 - Begin face - right of
Right Temp Steel Column

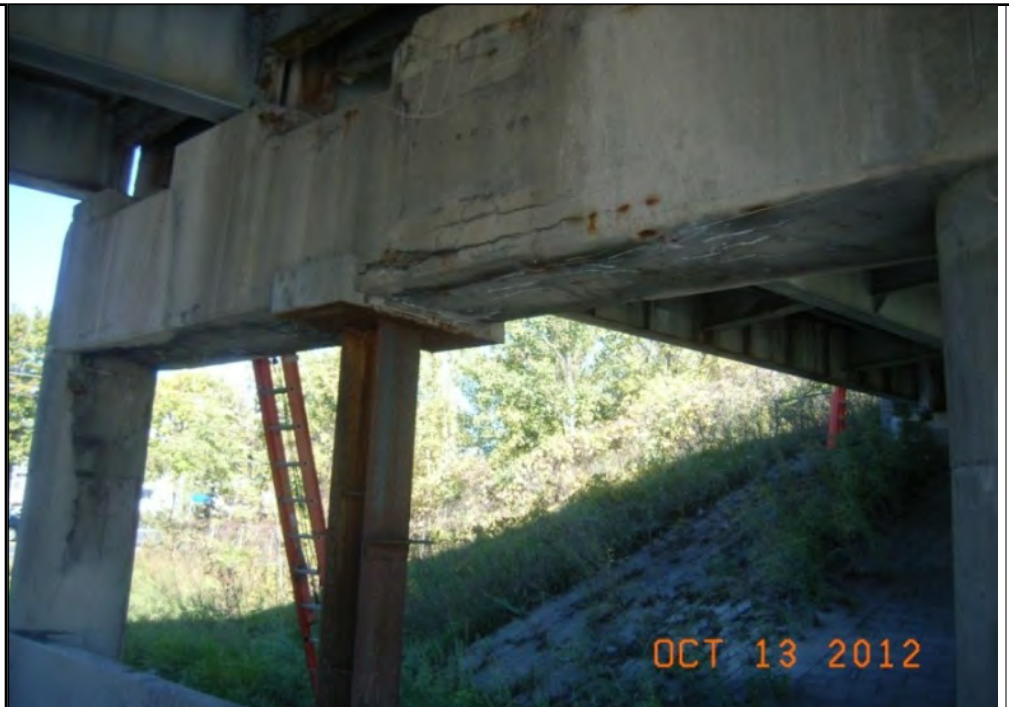
Photo Number: 52

Pier 2 - Cap Beam - Bay
1 - Begin and bottom face

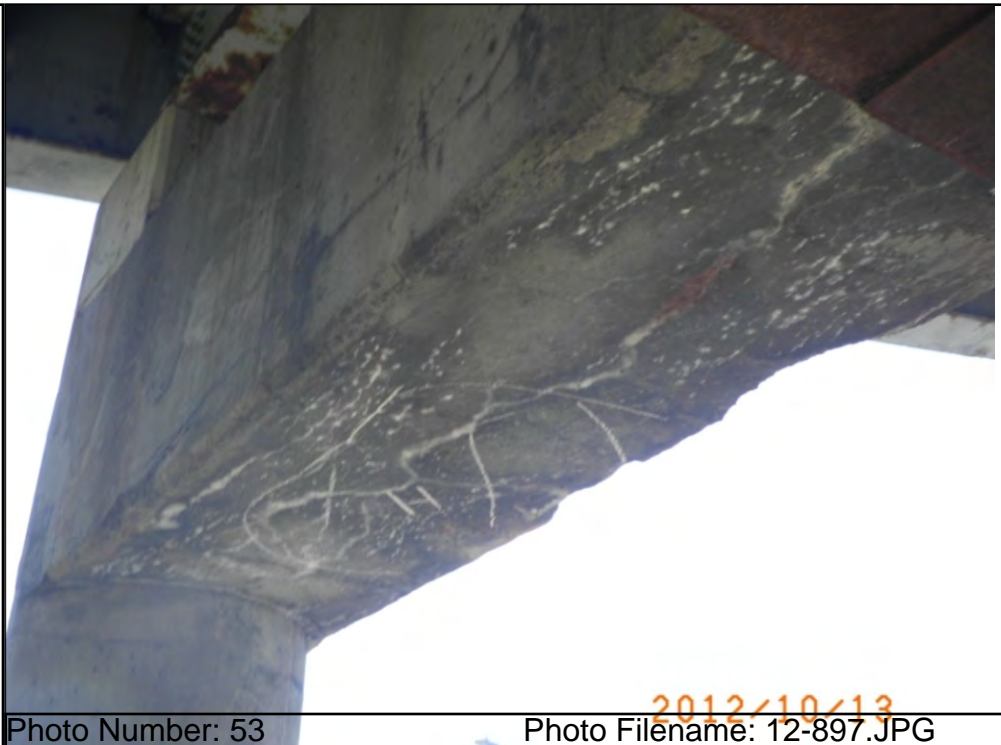
Photo Number: 53

Pier 2 - Cap Beam - Bay
2 - Right portion - End
and bottom face

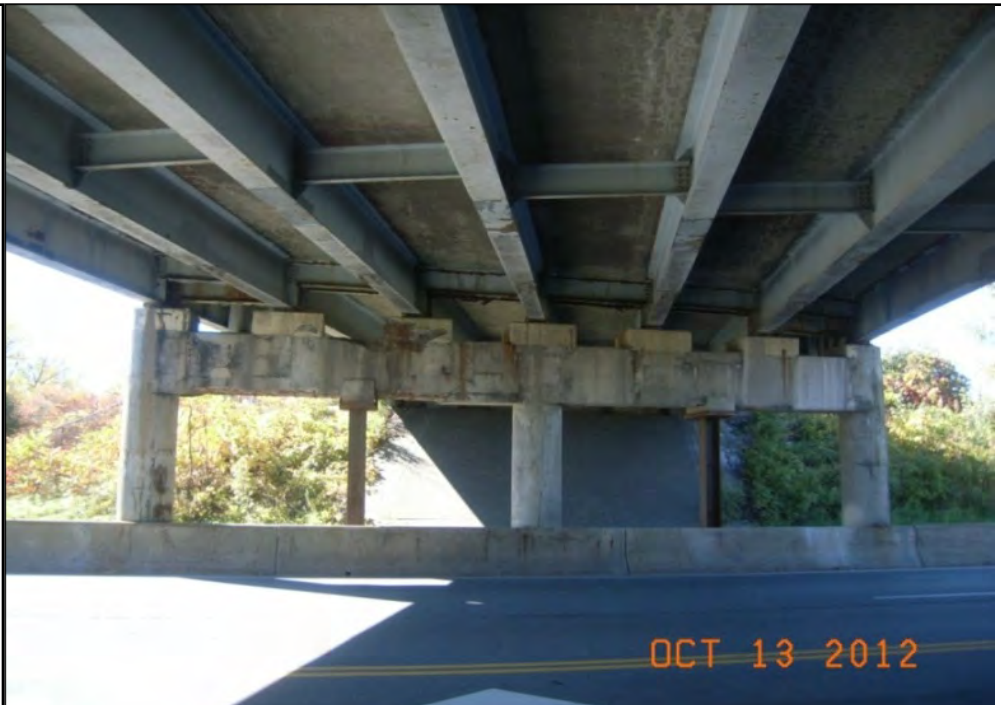
Photo Number: 54

Pier 2 - Pier Columns -
overview

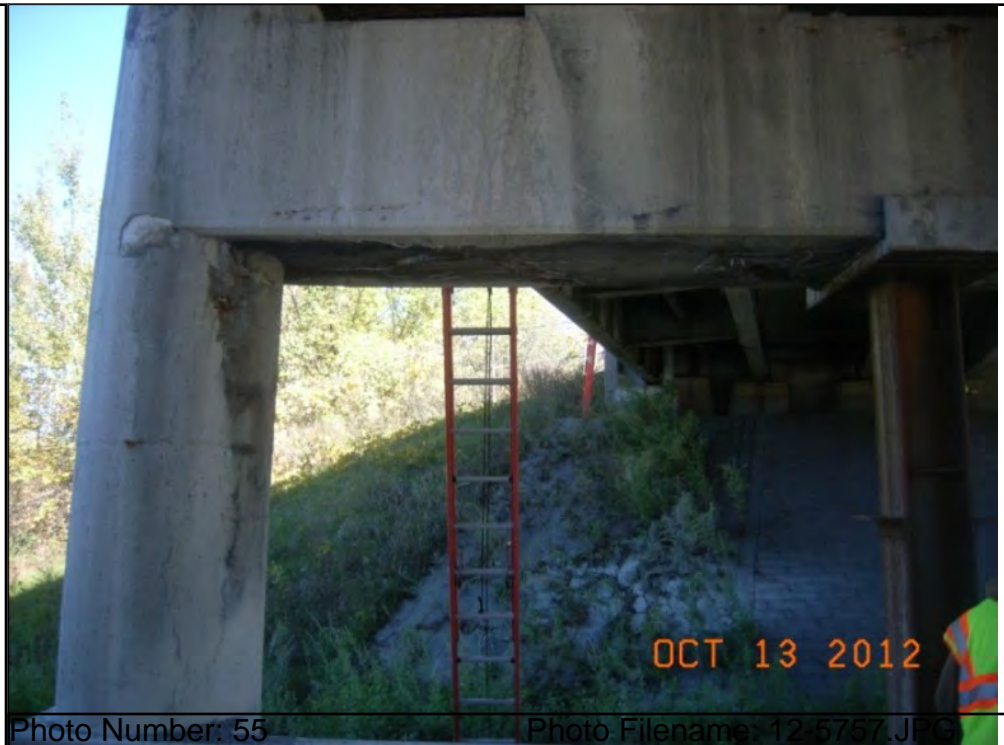
Pier 2 - Column 1 -
Begin Face

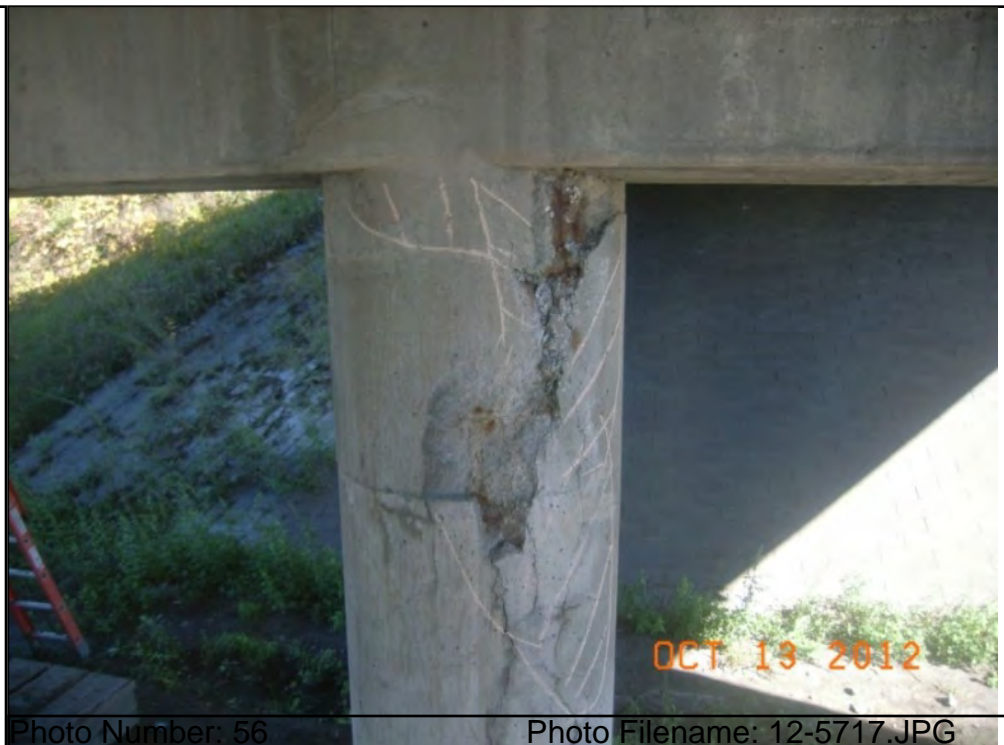
Pier 2 - Column 2 -
Begin face closeup

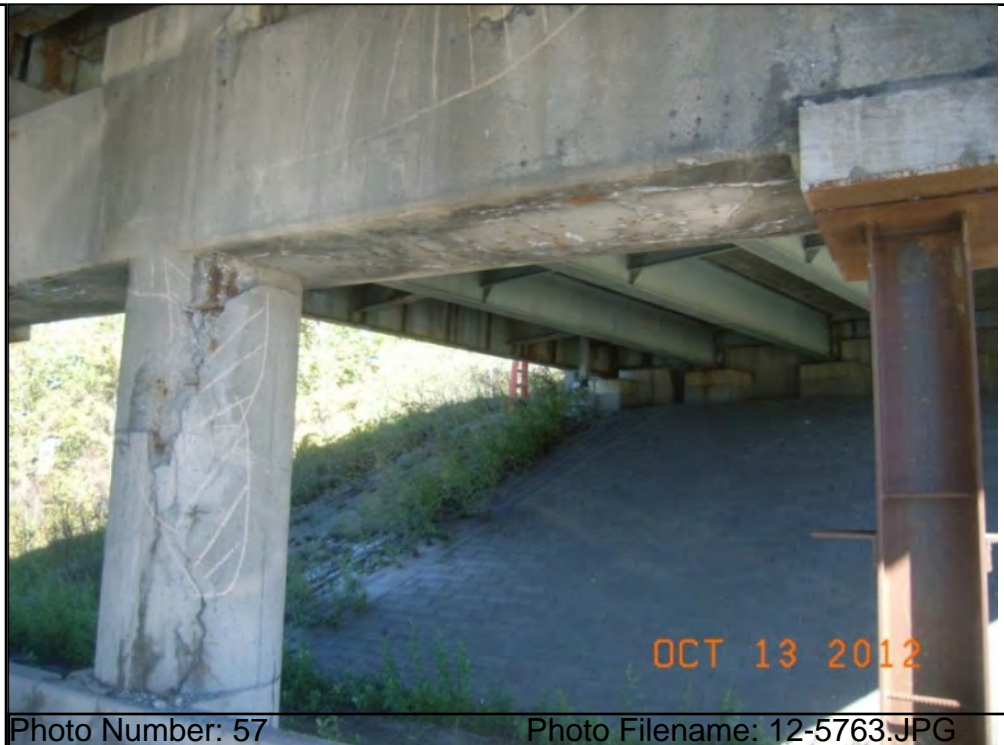
Photo Number: 57

Pier 2 - Column 2 -
Begin face overview

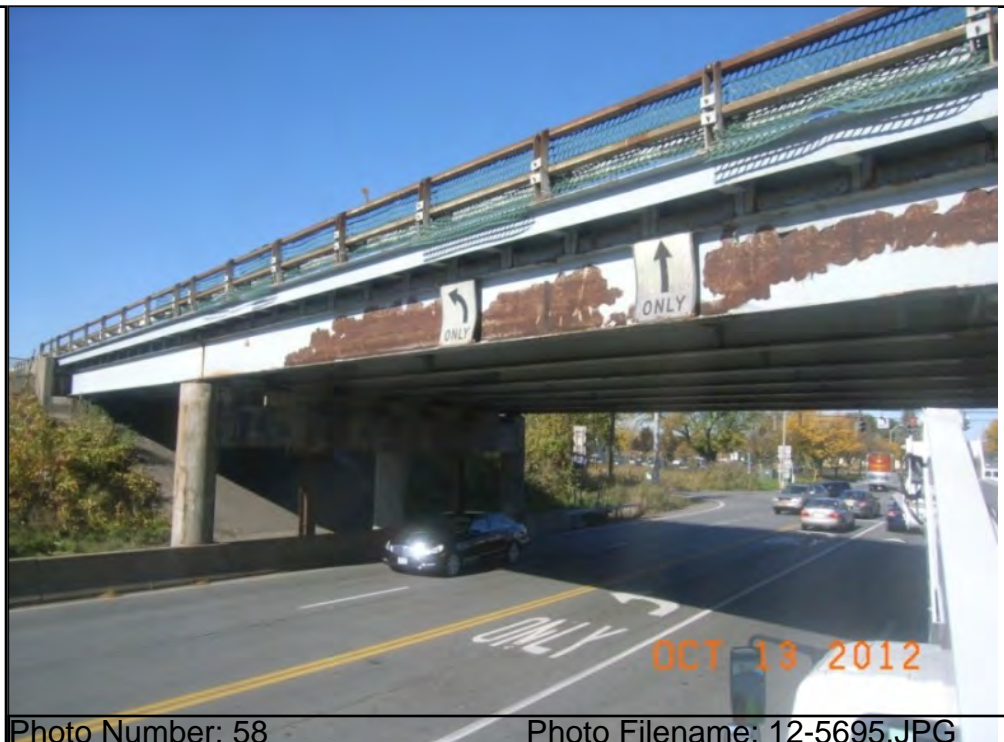
Photo Number: 58

Utilities - Signs - Span 2
Right

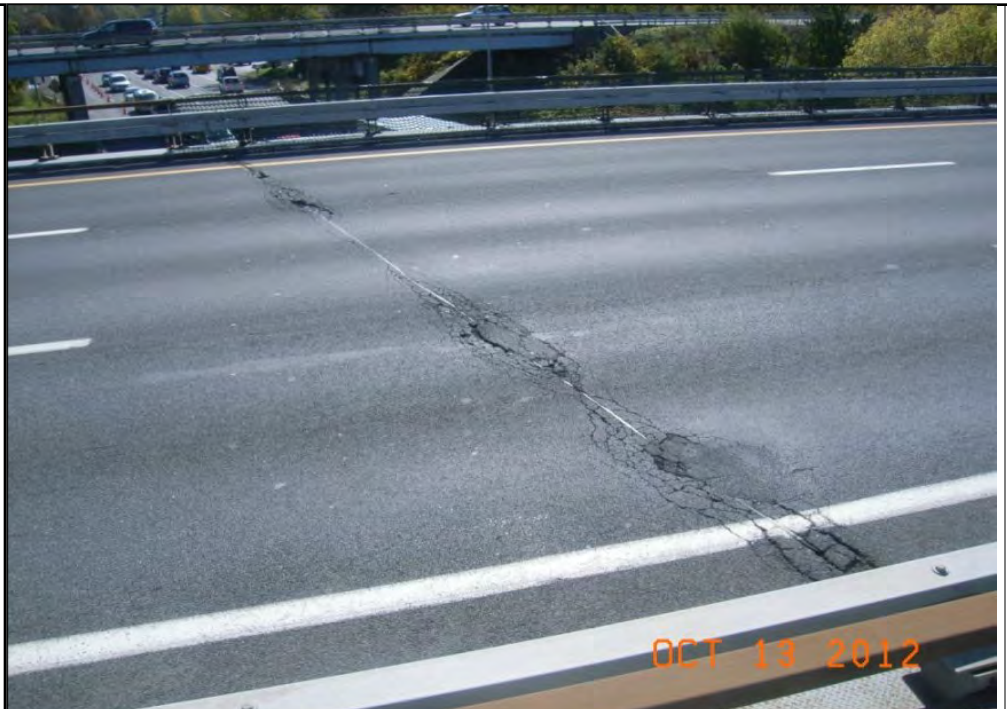
Photo Number: 59

Superstructure - Joints -
Pier 2 from left
